# UNDERWATER BRIDGE INSPECTION REPORT

STRUCTURE NO. 18506

RABBIT LAKE

PREPARED FOR THE  
MINNESOTA DEPARTMENT OF TRANSPORTATION  
BY  
COLLINS ENGINEERS, INC.  
JOB NO. 5221

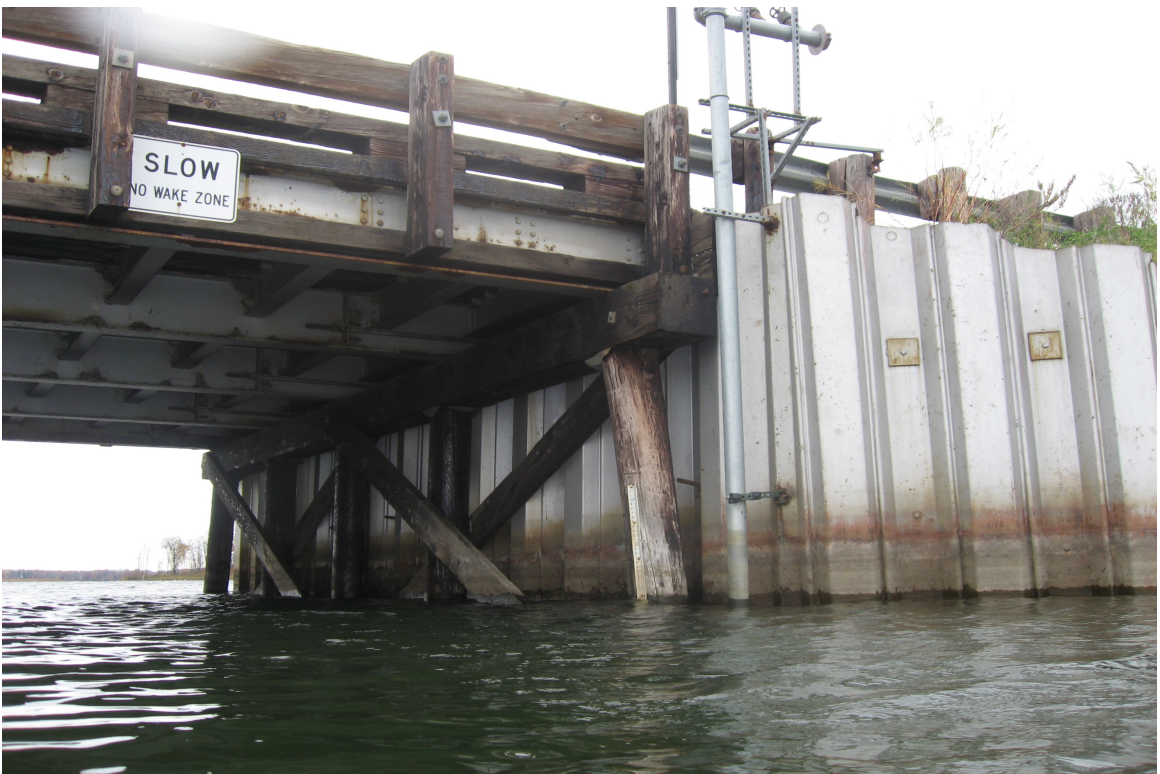
Photograph 2. View of South Abutment, Looking Southeast.

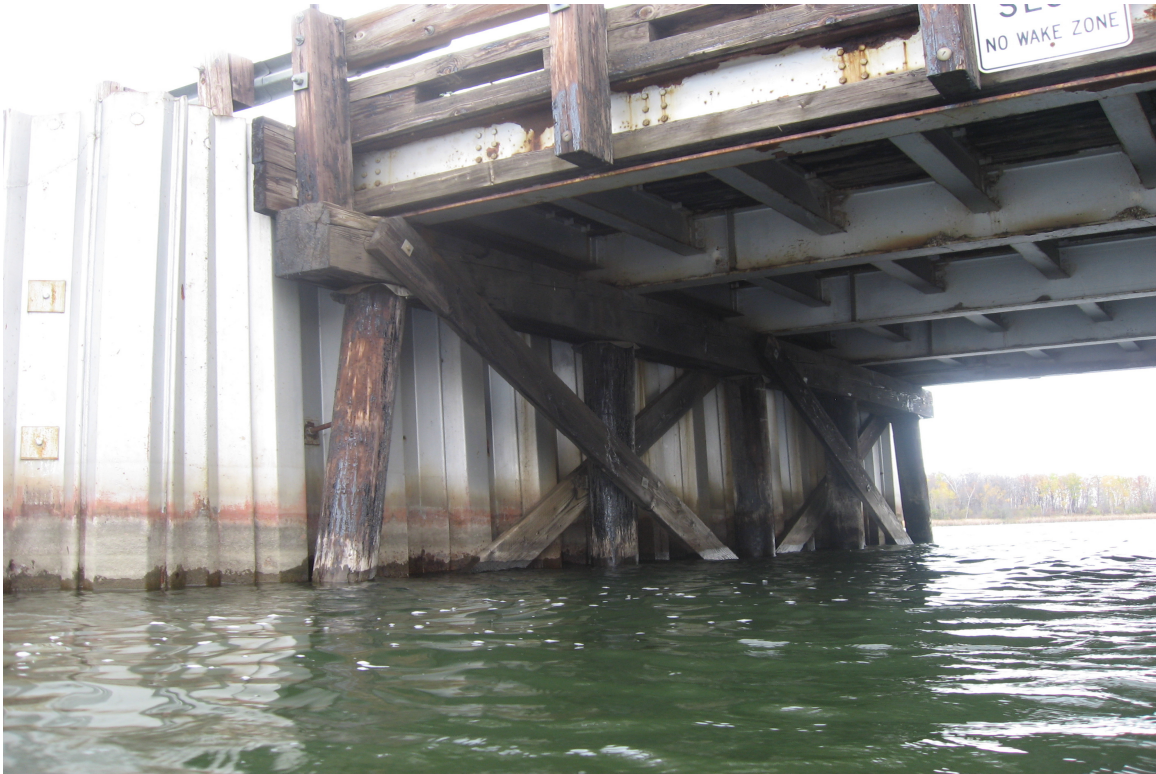
Photograph 3. View of North Abutment, Looking Northeast.

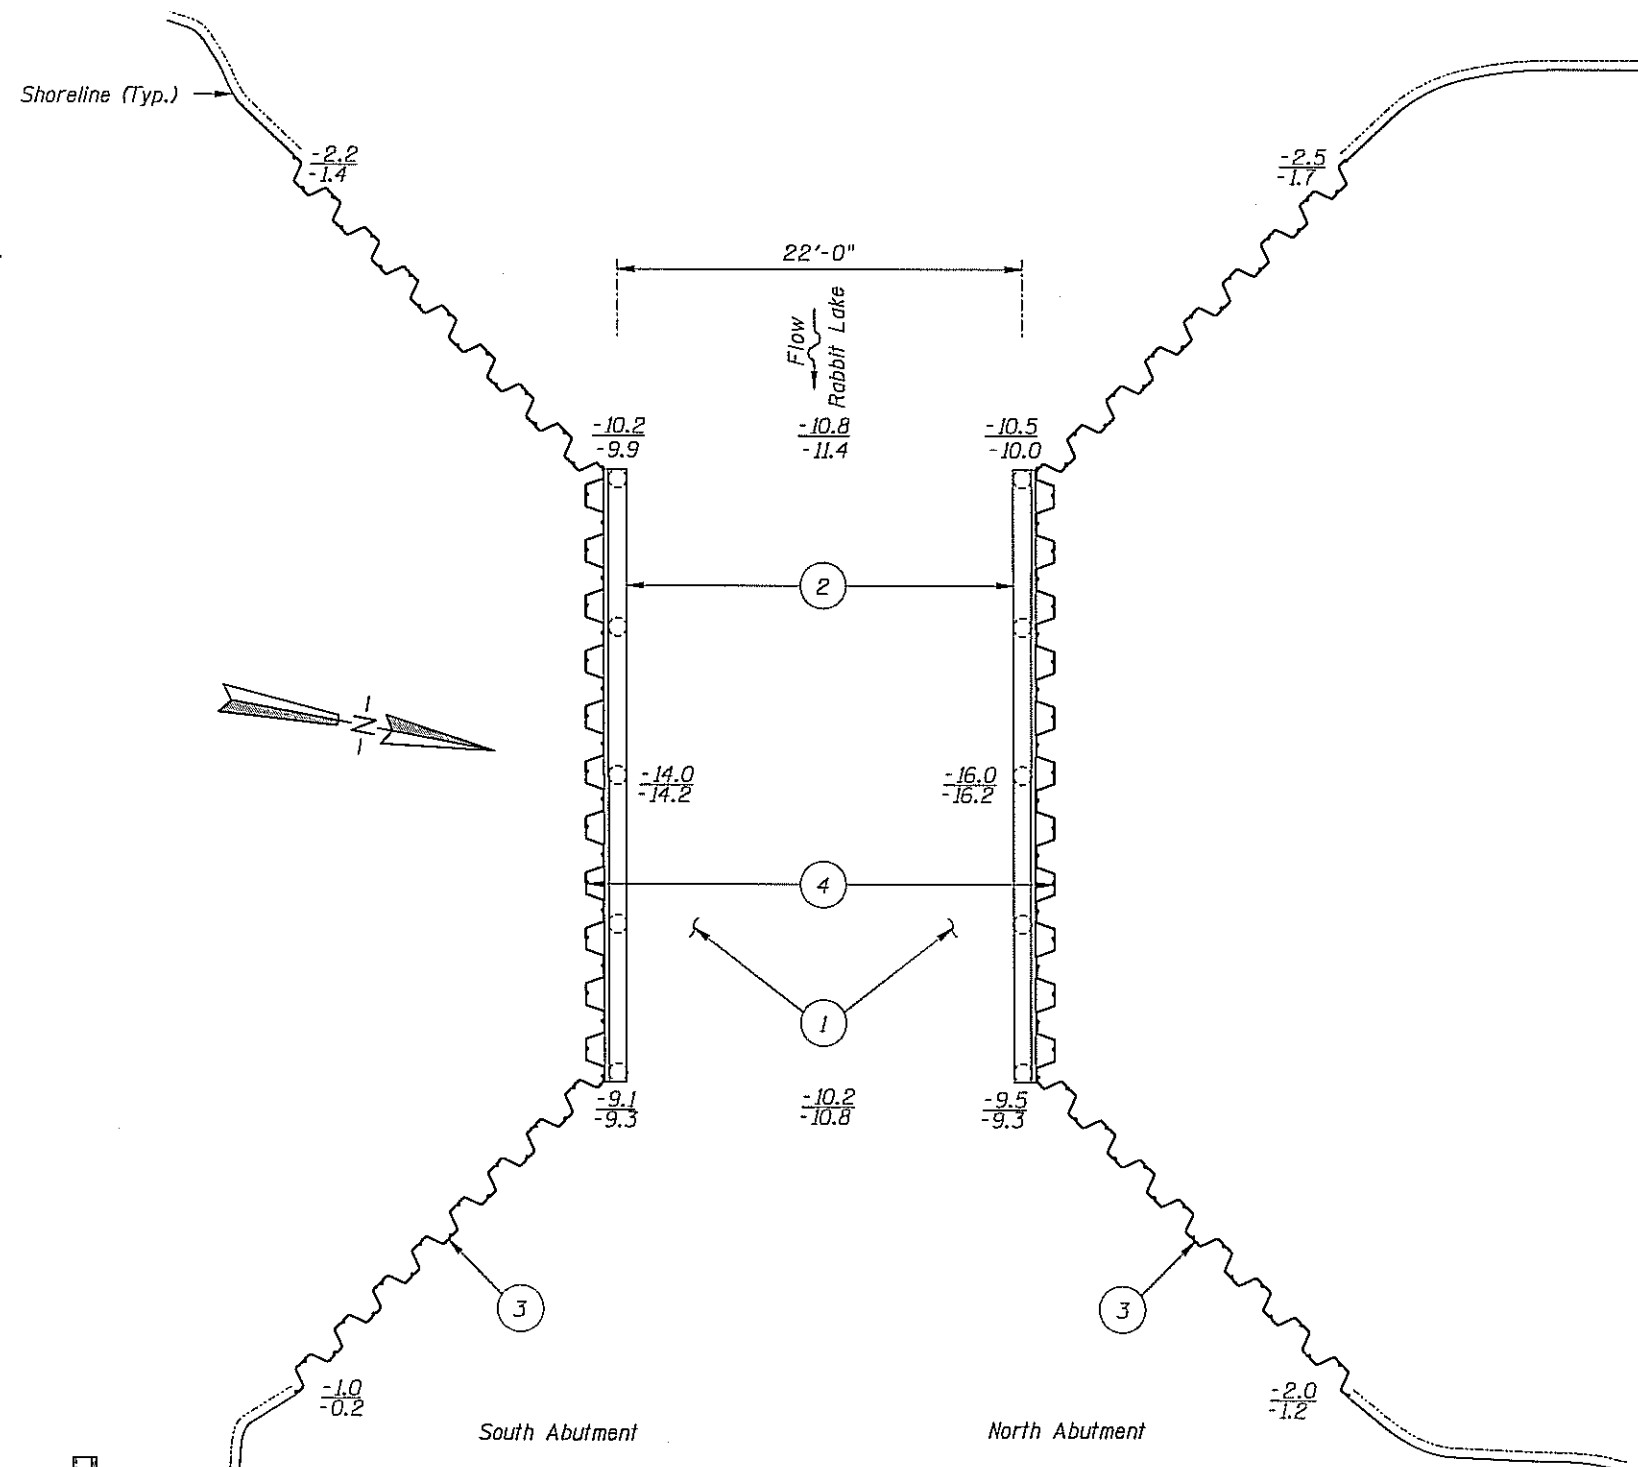
Figure No.: 1

1. The channel bottom consisted of silty sand with 2 to 4 inches of probe rod penetration.
2. The timber members exhibited very minor checking up to 1/8 inch wide.
3. Light aquatic growth was observed on the steel sheeting below the waterline.
4. The steel sheeting exhibited coating failure and surface corrosion on 50 to 100 percent of the surface area from 2 feet above to 6 inches below the waterline with minor delaminations and section loss of up to 1/32 inch in depth. From 6 inches below the waterline to the channel bottom, the steel sheeting exhibited rust nodules with up to 1/16-inch-deep pitting on less than 5 percent of the surface area.
